NUCLEAR MEDICINE CONSOLIDATION FACILITY
GLAN CLWYD HOSPITAL, BODELWYDDAN
ARBORICULTURAL IMPACT ASSESSMENT
JUNE 2023

Arboricultural Impact Assessment

D8166.04.001

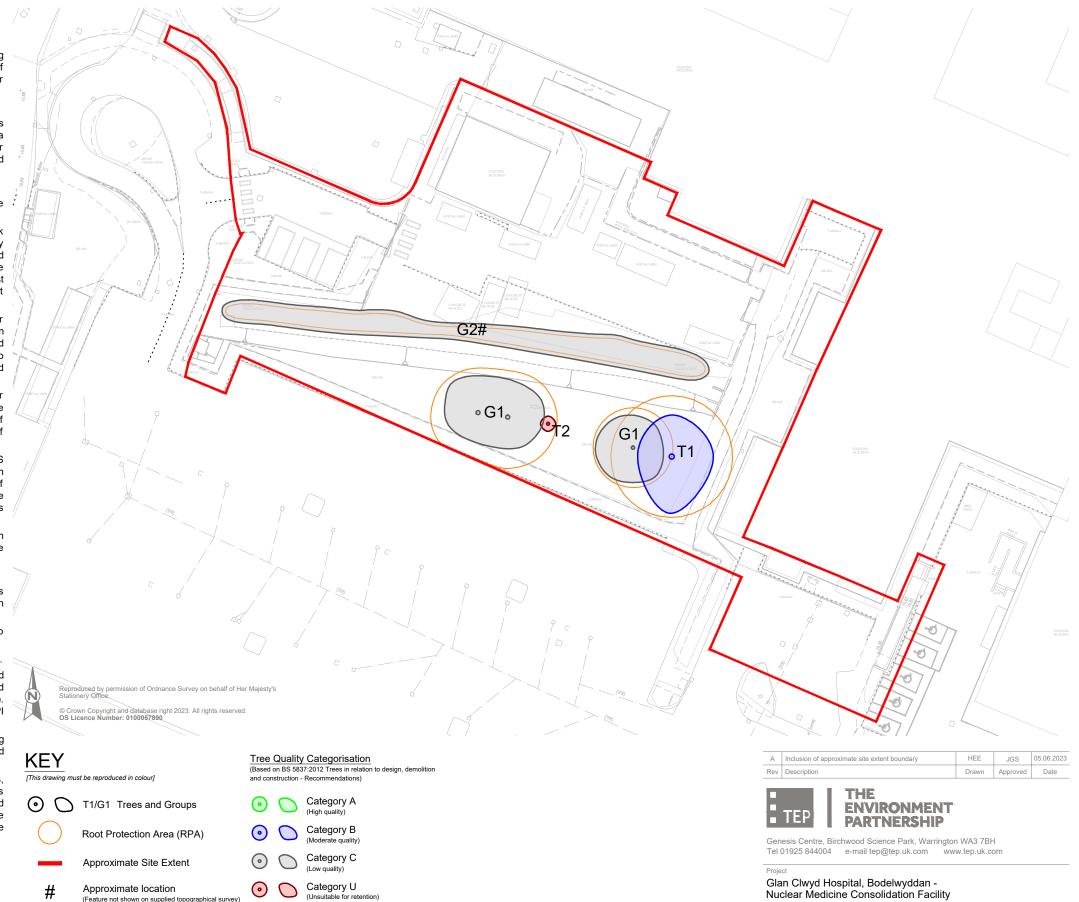
2.1. This drawing presents an overview of the existing trees within influencing distance of the proposed development. It also summarises the results of desktop searches for any designations, legal and regulatory restrictions or special status of relevance to arboriculture.

- 2.3. 2 individual trees and 2 tree groups were recorded within influencing distance of the application site.
- 2.4. Within the largest grass verge, south of the culverted ditch, are 5 hybrid black poplar trees (T1, T2 and G1). These trees have been unsympathetically pruned and heavily reduced in height previously, with the canopies of T1 and G1 largely comprising regrowth from the wounds. T2 is a standing dead pole with cracking and hollowing of the stem. Of these trees, T1 is the most significant due to its height, size and condition in comparison to the adjacent trees.

- 2.5. Group G2 comprises dense blackthorn and wych elm located within and either side of the culverted ditch. There are several dead elm stems present within the group, likely as a result of Dutch Elm Disease (*Ophiostoma novo-ulmi*) and due to the age of the stems within the group, it is likely others will succumb to the disease. The group currently acts as a screen between the car park and compound area.

- 2.8. Feature locations, their quality categories, canopy spreads and root protection areas are shown opposite. All arboricultural information recorded during the survey is presented at Appendix A.

- 2.7. A Root Protection Area (RPA) has been calculated in accordance with BS 5837. This is based on each tree's stem diameter at 1.5 metres and has been adjusted where necessary to most accurately represent the likely spread of roots in consideration of prevailing conditions. The RPA represents the minimum area around each tree that must be left undisturbed to ensure its survival.

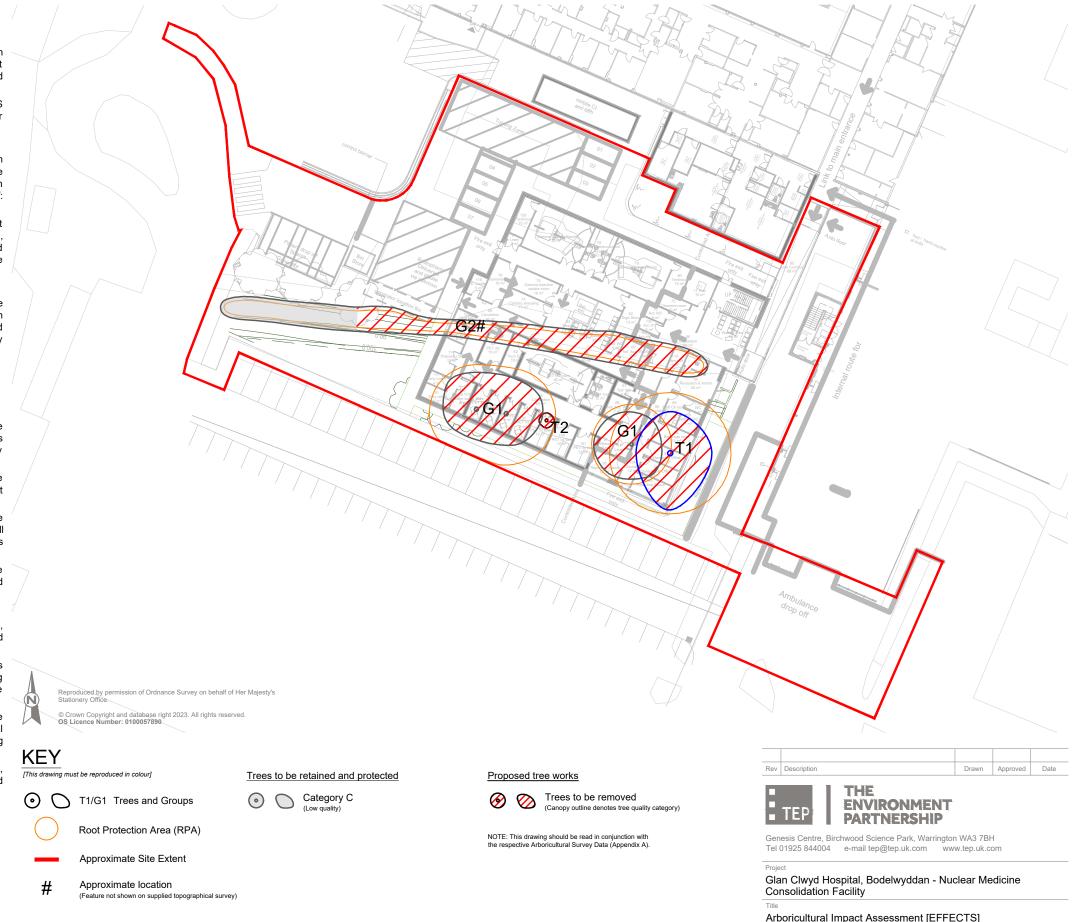
D8166.04.002

- 3.5.1. Removal of trees T1 and T2.
- 3.5.2. Full removal of group G1 equating 3 trees.
- 3.5.3. Partial removal of group G2 equating to c. 149m² of canopy loss/47 linear metres

- 3.6. The removal of all features listed above is necessary to accommodate the proposed building, with the exception of a small section of group G2 which is necessary to accommodate a proposed generator, shown indicatively opposite.

- 3.7. The most significant loss associated with the development would be the removal of moderate quality (Category B) tree T1. This is one of the largest trees within the hospital grounds.

- 3.8. All other trees proposed for removal are of low quality (Category C), with the exception of T2 which is of poor quality (Category U). The removal of G1 will result in further loss of amenity. The partial removal of G2 will result in the loss of continuous linear habitat, albeit one containing trees susceptible to disease.

- 3.9. Tree T2 is a Category U feature and is recommended for removal irrespective of development due to its condition and proximity to the existing car park and footpath

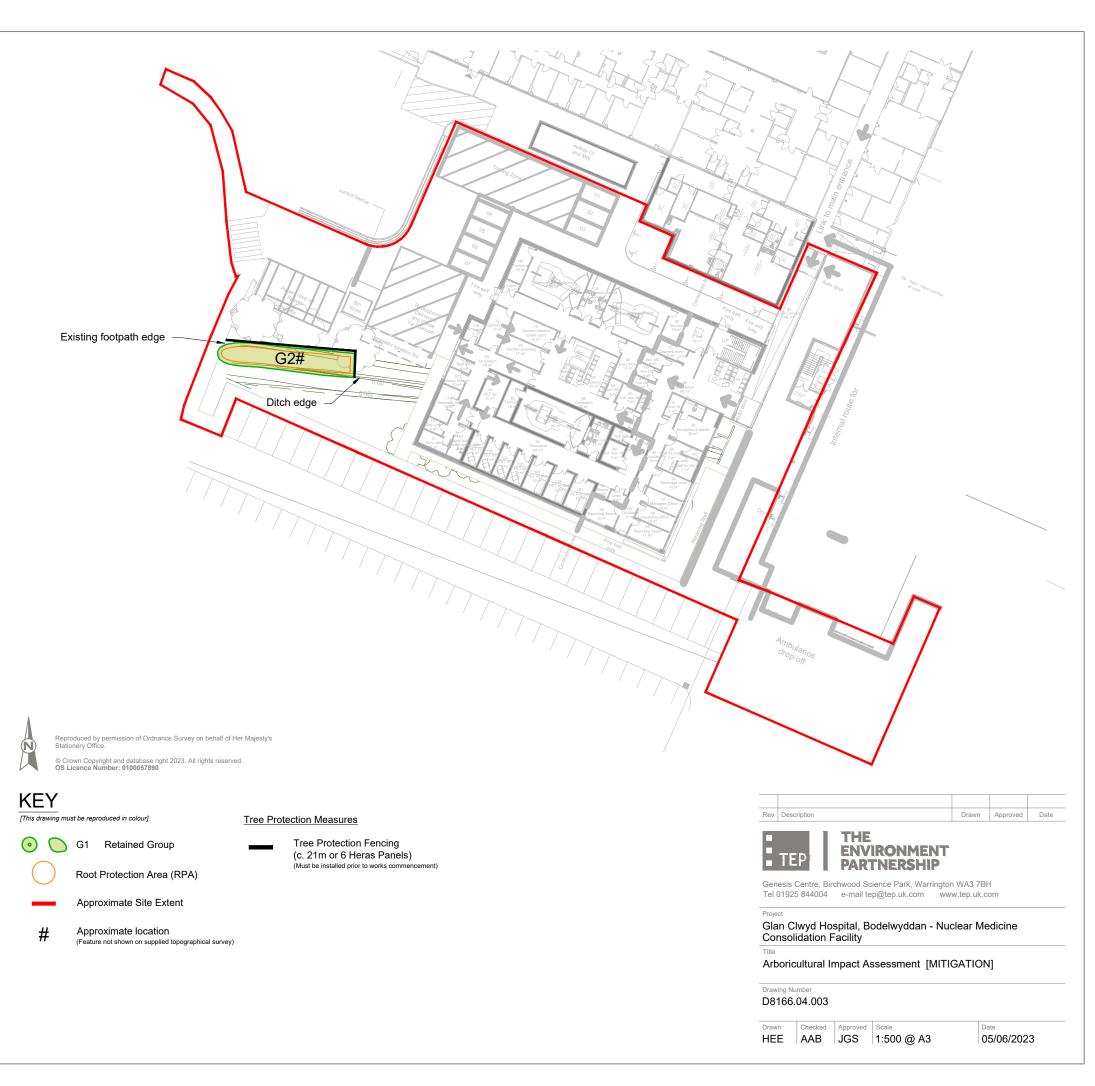
- 4.7. An Arboricultural Contractor will be appointed to undertake tree works.
- 4.8. The alignment of temporary tree protection measures shown opposite will be marked out accurately.

- 4.9. Tree works shown on drawing D8166.04.002 will be completed in accordance with BS3998: 2010 Tree work Recommendations.
- 4.10. Tree protection fencing will be installed as shown opposite as a **thick black** line.

- 4.13. Tree protection fencing will not be removed or realigned; and storage, excavation, level change, and access is prohibited within areas of tree protection except as described by this document or an approved Arboricultural Method Statement.

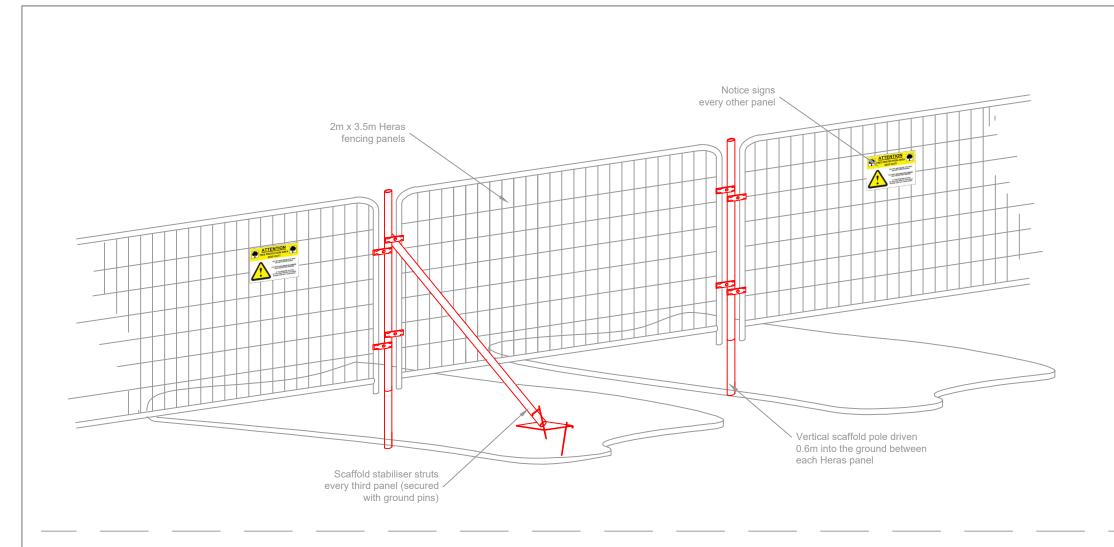
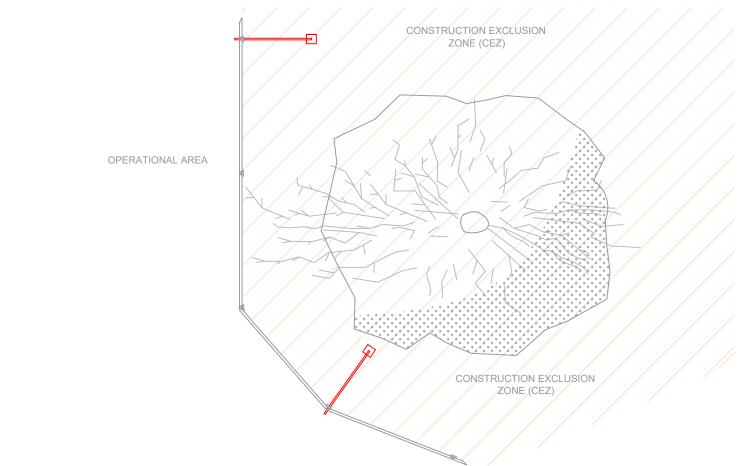
TEP.ARB.FEN.001

Per 3No. Heras panels (10.5m)	
Component	Quantity
2m x 3.5m Standard Heras panels	3
3m Galvenised steel scaffold pole	3
Heras fecurity fence clip	12
Heras stabilising support bar	1
Stabilising pin	2
Tree protection notice	2

Temporary tree protection fencing for use on soft surfaces

- 4.11. The specification for tree protection fencing will be as per Appendix C.
- 4.12. The site manager will inspect and verify the correct installation of tree protection fencing and maintain a photographic record.
